**Flood Control Project Maintenance
Levee Inspections****LMA District Cover Sheet****Spring 2015 Levee Inspection Results****Reclamation District No. 0544 Upper Roberts Island**

Spring 2015 Levee Inspection Results

Reclamation District No. 0544 Upper Roberts Island

Waterway			Bank	Unit Miles
Unit No. 01 San Joaquin River			Left	6.05
	Spring (March - May)	Summer (June - August)	(September - November) Fall	Winter (December - February)
Unit Maintenance Rating (Fall Only)				
Date of Inspection	04/28/2015 - 04/28/2015			
DWR Inspector	Richard Willoughby			
Accompanied By

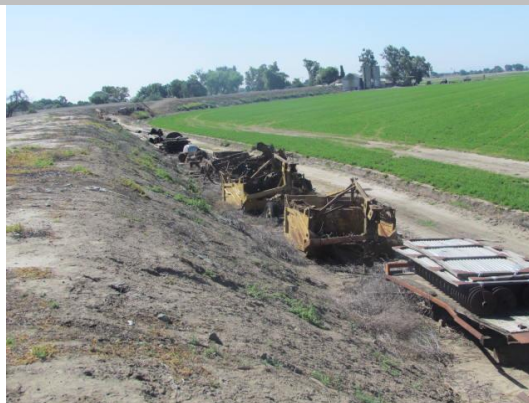
Photo 1 of 3 : SP_2015_RD0544_108_4_20150430_00070.jpg

LM Start	0.23	Rating **	M	Issue No.	4
LM End	0.23	Issue Type +	Ma	Location *	LS
Category	Earthen Levee			GPS Latitude/Longitude	
				Start	End
Item	Encroachments			37.867590 °	37.867590 °
				-121.327813 °	-121.327813 °
DWR ID	DWR_RD0544_01_s_2012_4				
Action/Comments					
Equipment					
Inspector Comments: Farm equipment and supplies stored at landward toe.

Looking south at farm equipment at landward toe. (Spring 2015)

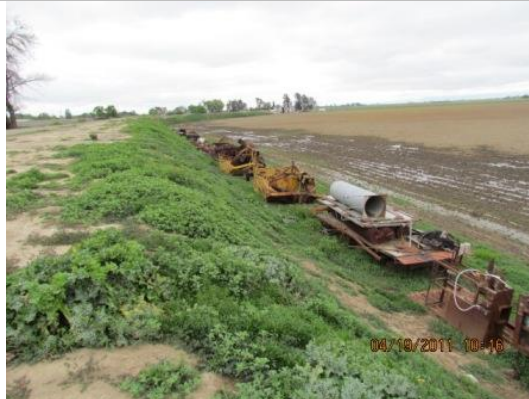
Photo 3 of 3 : SP_2015_RD0544_108_4_20150309_00004.jpg

LM Start	0.23	Rating **	M	Issue No.	4 (cont)	
LM End	0.23	Issue Type +	Ma	Location *	LS	
Category	Earthen Levee			GPS Latitude/Longitude		
				Start		End
Item	Encroachments			37.867590 °		37.867590 °
				-121.327813 °		-121.327813 °
DWR ID	DWR_RD0544_01_s_2012_4					
Action/Comments						
Equipment						
Inspector Comments: Farm equipment and supplies stored at landward toe.

Looking south at equipment along landside toe.

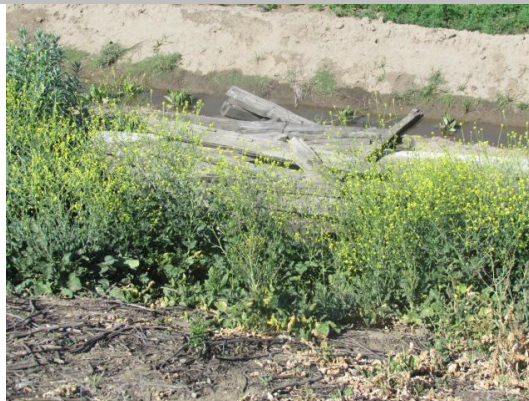
Photo 1 of 1 : SP_2015_RD0544_108_84_20150430_00071.jpg

LM Start	0.26	Rating **	M	Issue No.	84
LM End	0.26	Issue Type +	En	Location *	LS
Category	Earthen Levee			GPS Latitude/Longitude	
				Start	End
Item	Encroachments			37.867087 °	37.867087 °
				-121.327802 °	-121.327802 °
DWR ID	DWR_RD0544_01_s_2015_84				
Action/Comments					
Material Inspector Comments: Landowner stock pile old wooden fencing at landward toe.

Looking west at old wooden fencing stock pile at landward toe.

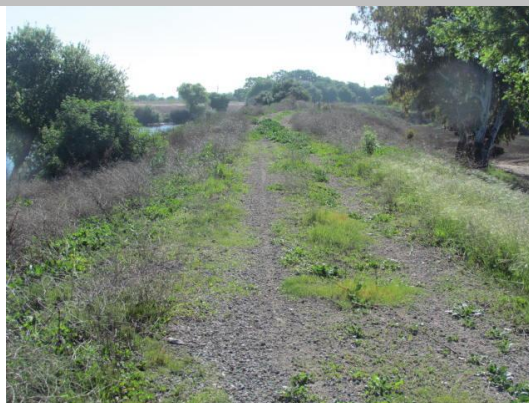
Photo 1 of 2 : SP_2015_RD0544_108_3_20150309_00001.jpg

Looking south at typical view of levee. (Spring 2014)

LM Start	0.48	Rating **	A/W	Issue No.	3
LM End	0.67	Issue Type +	Ma	Location *	WS
Category	Earthen Levee			GPS Latitude/Longitude	
				Start	End
Item	Vegetation			37.864578 °	37.863753 °
				-121.326210 °	-121.322835 °
DWR ID	DWR_RD0544_01_s_2012_3				
Action/Comments					
Remove the wild growth other than native grasses from the levee slopes.

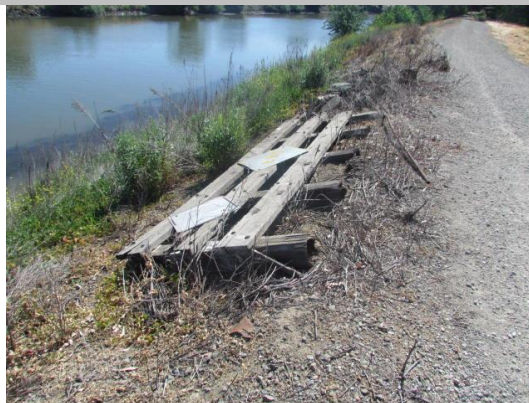
Photo 1 of 1 : SP_2015_RD0544_108_86_20150430_00074.jpg

LM Start	0.64	Rating **	M	Issue No.	86
LM End	0.64	Issue Type +	En	Location *	WS
Category	Earthen Levee			GPS Latitude/Longitude	
				Start	End
Item	Encroachments			37.863972 °	37.863972 °
				-121.323443 °	-121.323443 °
DWR ID	DWR_RD0544_01_s_2015_86				
Action/Comments					
Sign					
Inspector Comments: Old "dead end" sign on waterward slope.

Looking southeast at wooden sign on waterward slope.

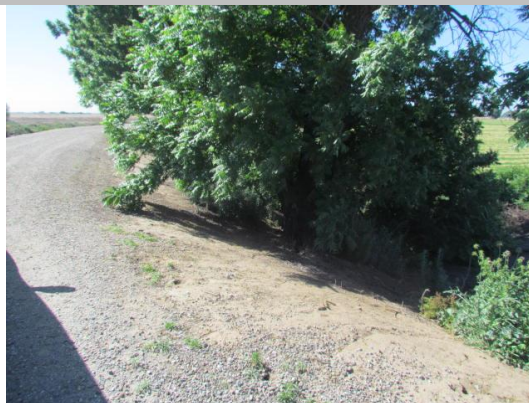
Photo 1 of 1 : SP_2015_RD0544_108_39_20150430_00075.jpg

Looking southwest at untrimmed tree at landward slope and toe.

LM Start	1.12	Rating **	M	Issue No.	39
LM End	1.12	Issue Type +	Ma	Location *	LS
Category	Earthen Levee			GPS Latitude/Longitude	
				Start	End
Item	Trim / Thin Trees			37.859423 °	37.859423 °
				-121.318328 °	-121.318328 °
DWR ID	DWR_RD0544_01_s_2012_39				
Action/Comments					
Trim trees to at least five feet above ground level.

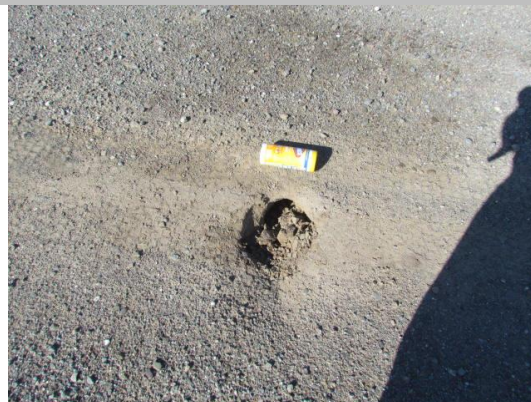
Photo 1 of 2 : SP_2015_RD0544_108_90_20150309_00050.jpg

LM Start	2.01	Rating **	A/W	Issue No.	90
LM End	2.01	Issue Type +	Ma	Location *	CR
Category	Earthen Levee			GPS Latitude/Longitude	
				Start	End
Item	Animal Control			37.850825 °	37.850825 °
				-121.322475 °	-121.322475 °
DWR ID	DWR_RD0544_01_s _ 2014_90				
Action/Comments					
No rodents visible, but rodent burrows visible; need to backfill and compact or grout burrows.					
Inspector Comments: LMA grouted rodent hole on levee crown.

Looking at rodent hole on levee crown.

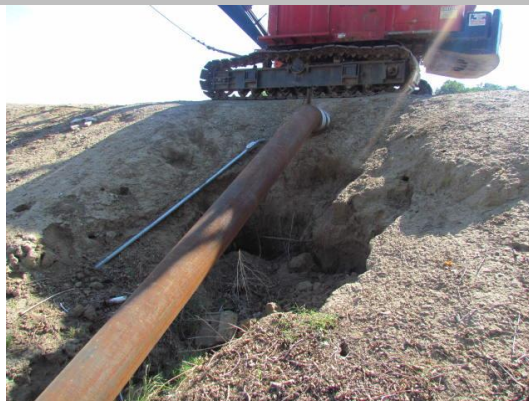
Photo 3 of 3 : SP_2015_RD0544_108_23_20150309_00026.jpg

LM Start	2.26	Rating **	U	Issue No.	23 (cont)
LM End	2.26	Issue Type +	Ma	Location *	LS
Category	Earthen Levee			GPS Latitude/Longitude	
				Start	End
Item	Erosion / Bank Caving			37.848155 °	37.848155 °
				-121.324897 °	-121.324897 °
DWR ID	DWR_RD0544_01_s_2012_23				
Action/Comments					
Schedule repair of erosion site prior to the next inspection. Inspector Comments: Caving/erosion around irrigation pipe on landside slope.

Looking east at erosion under irrigation pipe on landside slope.

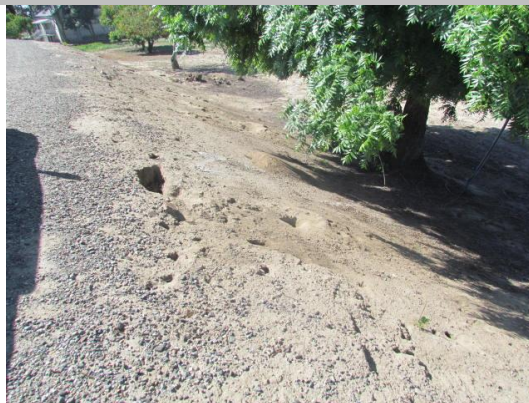
Photo 1 of 2 : SP_2015_RD0544_108_34_20150430_00076.jpg

Looking south at several rodent holes on landward shoulder and slope.

LM Start	2.32	Rating **	M	Issue No.	34
LM End	2.36	Issue Type +	Ma	Location *	LS
Category	Earthen Levee			GPS Latitude/Longitude	
				Start	End
Item	Animal Control			37.847292 °	37.846743 °
				-121.324662 °	-121.324336 °
DWR ID	DWR_RD0544_01_s_2012_34				
Action/Comments					
Exterminate rodents and backfill and compact or grout burrows. Inspector Comments: Several rodent hole within this reach.

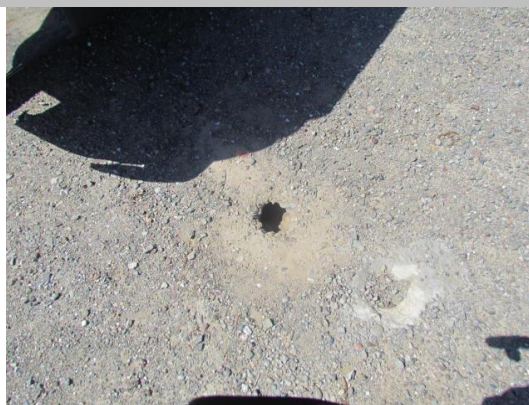
Photo 2 of 2 : SP_2015_RD0544_108_34_20150430_00077.jpg

Looking at rodent hole on levee crown.

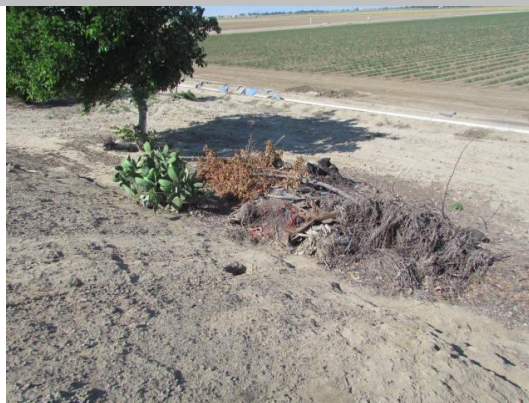
Photo 1 of 1 : SP_2015_RD0544_108_7_20150309_00007.jpg

LM Start	2.33	Rating **	M	Issue No.	7
LM End	2.33	Issue Type +	Ma	Location *	LS
Category	Earthen Levee			GPS Latitude/Longitude	
				Start	End
Item	Encroachments			37.847108 °	37.847108 °
				-121.324585 °	-121.324585 °
DWR ID	DWR_RD0544_01_s_2012_7				
Action/Comments					
Garbage					
Inspector Comments: Garbage and prunings at landside toe.

Looking southwest at garbage at landside toe.

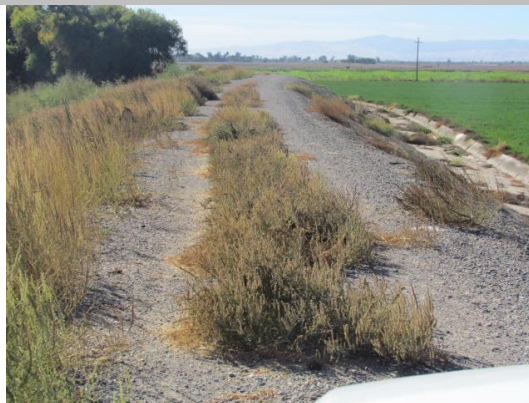
Photo 1 of 1 : SP_2015_RD0544_108_100_20150309_00056.jpg

Looking south at vegetation on levee crown.

LM Start	2.65	Rating **	A/W	Issue No.	100
LM End	2.94	Issue Type +	Ma	Location *	CR
Category	Earthen Levee			GPS Latitude/Longitude	
				Start	End
Item	Vegetation			37.843262 °	37.840656 °
				-121.321666 °	-121.318590 °
DWR ID	DWR_RD0544_01_f_2014_100				
Action/Comments					
Remove the wild growth other than native grasses from the levee slopes.

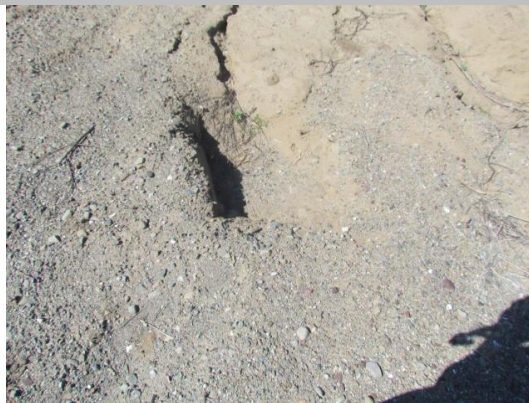
Photo 1 of 2 : SP_2015_RD0544_108_107_20150430_00078.jpg

Looking south at depression on landward slope.

LM Start	2.95	Rating **	M	Issue No.	107
LM End	2.96	Issue Type +	Ma	Location *	LS
Category	Earthen Levee			GPS Latitude/Longitude	
				Start	End
Item	Erosion / Bank Caving			37.840560 °	37.840467 °
				-121.318463 °	-121.318367 °
DWR ID	DWR_RD0544_01_s_2015_107				
Action/Comments					
Note and monitor erosion site. Inspector Comments: Several depressions on landward slope within this reach.

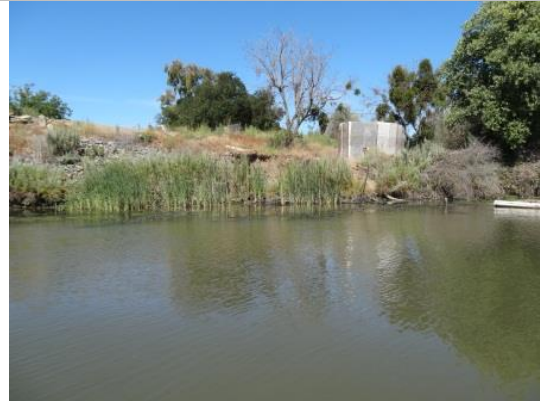
Photo 1 of 1 : SP_2015_RD0544_108_78_20150309_00048.jpg

LM Start	2.95	Rating **	U	Issue No.	78
LM End	2.95	Issue Type +	Ma	Location *	WS
Category	Supplemental			GPS Latitude/Longitude	
				Start	End
Item	DWR Erosion Survey			37.840697 °	37.840697 °
				-121.318252 °	-121.318252 °
DWR ID	DWR_RD0544_01_s _ 2015_78				
Action/Comments					
Inspector Comments: 6/19/2014: No significant change observed. 08/13/2013: Pump has been removed. A larger pocket erosion has been found at the erosion site. 08/07/2012: The erosion is immediately upstream of a river bend. Dense vegetation is visible at the erosion site. [2014 Site ID:RD0544U01RM49.67]

Upstream view of the site.

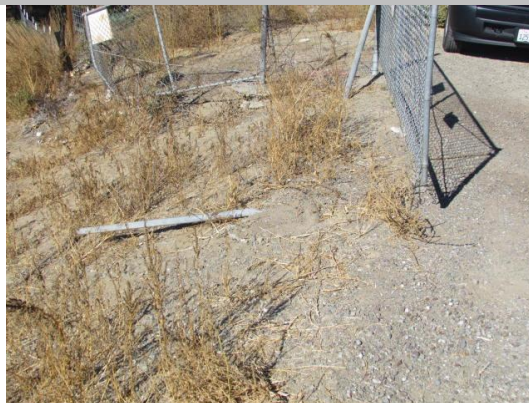
Photo 2 of 12 : SP_2015_RD0544_108_16_20150309_00011.jpg

Looking north at inch and half pipe at landward shoulder.

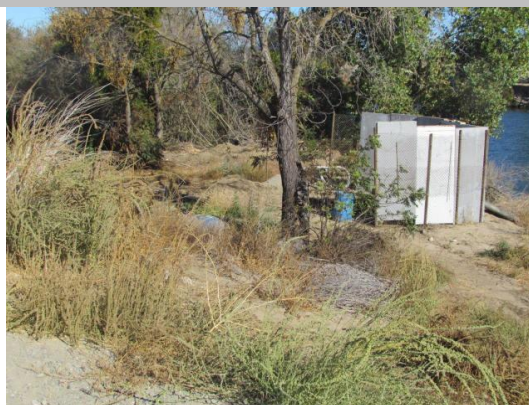
Photo 3 of 12 : SP_2015_RD0544_108_16_20150309_00012.jpg

Looking north at concrete wall on waterward berm.

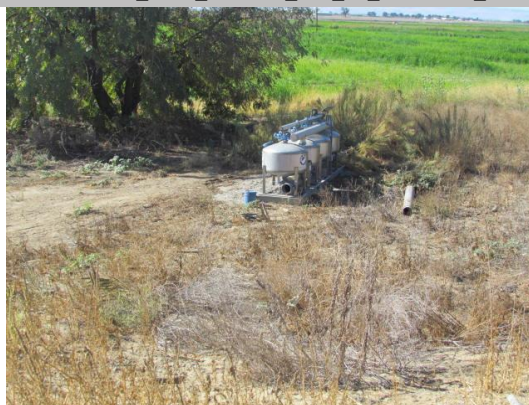
Photo 4 of 12 : SP_2015_RD0544_108_16_20150309_00013.jpg

Looking west at filter system on landward berm

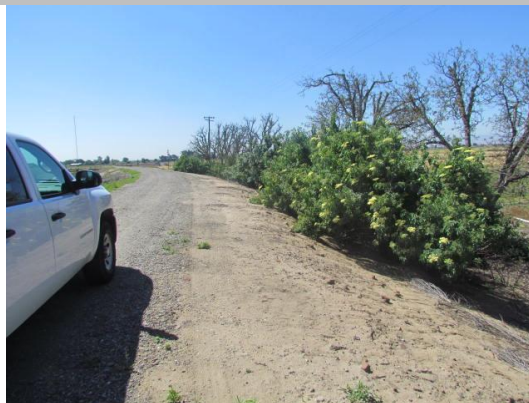
Photo 1 of 1 : SP_2015_RD0544_108_49_20150430_00080.jpg

Looking southwest at untrimmed trees at landward toe.

LM Start	3.22	Rating **	M	Issue No.	49
LM End	3.84	Issue Type +	Ma	Location *	WS
Category	Earthen Levee			GPS Latitude/Longitude	
				Start	End
Item	Vegetation			37.836763 °	37.829195 °
				-121.317307 °	-121.311918 °
DWR ID	DWR_RD0544_01_s _ 2012_49				
Action/Comments					
Remove the wild growth other than native grasses from the levee slopes.

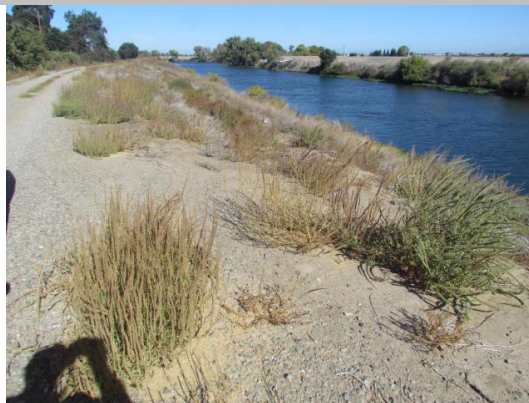
Photo 1 of 1 : SP_2015_RD0544_108_37_20150309_00033.jpg

LM Start	3.28	Rating **	M	Issue No.	37
LM End	3.28	Issue Type +	En	Location *	WS
Category	Earthen Levee			GPS Latitude/Longitude	
				Start	End
Item	Encroachments			37.835951 °	37.835951 °
				-121.317062 °	-121.317062 °
DWR ID	DWR_RD0544_01_s _ 2012_37				
Action/Comments					
Ramp					
Inspector Comments: Landowner has cut new ramp on waterside slope.

Looking north at ramp on waterward slope.

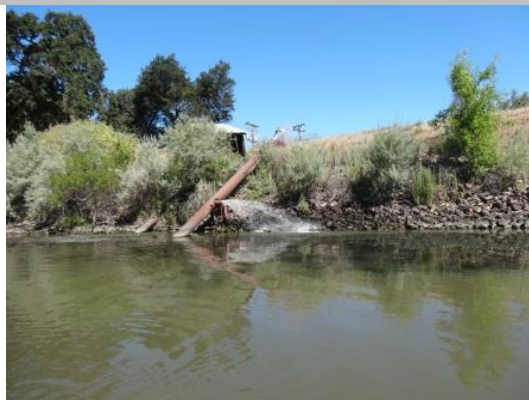
Photo 1 of 1 : SP_2015_RD0544_108_79_20150309_00049.jpg

LM Start	4.23	Rating **	M	Issue No.	79
LM End	4.23	Issue Type +	Ma	Location *	WS
Category	Supplemental			GPS Latitude/Longitude	
				Start	End
Item	DWR Erosion Survey			37.825248 °	37.825248 °
				-121.313856 °	-121.313856 °
DWR ID	DWR_RD0544_01_s _ 2015_79				
Action/Comments					
Inspector Comments: 06/19/2014: No significant change observed. 08/13/2013: The erosion has been caused by irrigation pipe. [2014 Site ID:RD0544U01RM51.04]

View from upstream of the site.

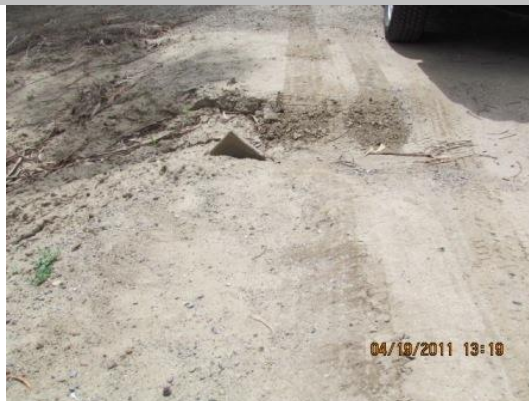
Photo 2 of 2 : SP_2015_RD0544_108_58_20150309_00038.jpg

Looking south at depression greater than 6" on waterside shoulder.

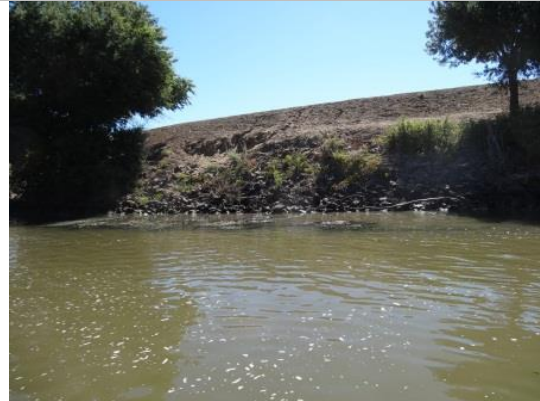
Photo 1 of 1 : SP_2015_RD0544_108_101_20150309_00057.jpg

LM Start	4.32	Rating **	U	Issue No.	101
LM End	4.32	Issue Type +	Ma	Location *	WS
Category	Supplemental			GPS Latitude/Longitude	
				Start	End
Item	DWR Erosion Survey			37.824360 °	37.824360 °
				-121.314360 °	-121.314360 °
DWR ID	DWR_RD0544_01_s_2015_101				
Action/Comments					
Inspector Comments: 6/19/2014: No significant change observed. 08/13/2013: This erosion has been caused by instability of the levee . Larger trees exist downstream of the erosion site. [2014 Site ID:RD0544U01RM51.09]

View from downstream.

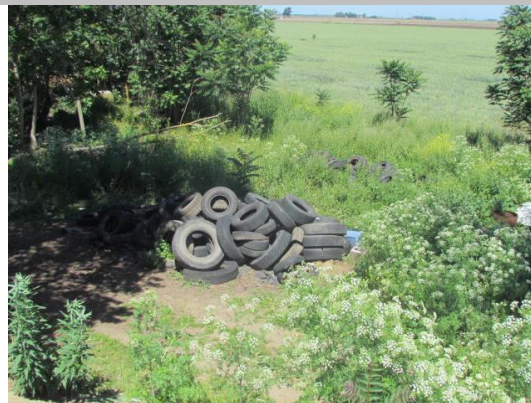
Photo 1 of 1 : SP_2015_RD0544_108_27_20150430_00081.jpg

LM Start	4.68	Rating **	U	Issue No.	27
LM End	4.68	Issue Type +	En	Location *	LS
Category	Earthen Levee			GPS Latitude/Longitude	
				Start	End
Item	Encroachments			37.821847 °	37.821847 °
				-121.320027 °	-121.320027 °
DWR ID	DWR_RD0544_01_s_2012_27				
Action/Comments					
Garbage					
Inspector Comments: Tires stock pile on landward toe.

Looking west at tires stock pile on landward berm.

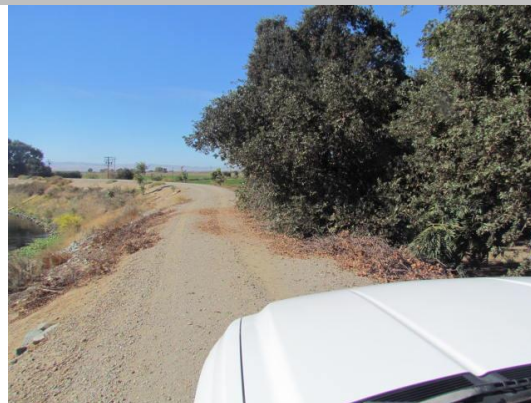
Photo 1 of 1 : SP_2015_RD0544_108_105_20150309_00058.jpg

LM Start	4.69	Rating **	U	Issue No.	105
LM End	4.69	Issue Type +	Ma	Location *	LS
Category	Earthen Levee			GPS Latitude/Longitude	
				Start	End
Item	Trim / Thin Trees			37.821775 °	37.821775 °
				-121.320203 °	-121.320203 °
DWR ID	DWR_RD0544_01_f_2014_105				
Action/Comments					
Thin trees to allow visibility of the ground and room to flood fight.					
Inspector Comments: Tree has overgrown onto levee crown.

Looking south at overgrown tree on landward shoulder.

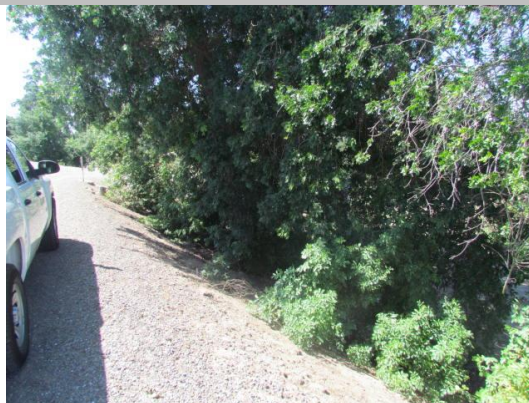
Photo 1 of 1 : SP_2015_RD0544_108_112_20150430_00082.jpg

LM Start	4.77	Rating **	U	Issue No.	112
LM End	4.77	Issue Type +	Ma	Location *	LS
Category	Earthen Levee			GPS Latitude/Longitude	
				Start	End
Item	Trim / Thin Trees			37.820828 °	37.820828 °
				-121.321193 °	-121.321193 °
DWR ID	DWR_RD0544_01_s_2015_112				
Action/Comments					
Trim trees to at least five feet above ground level.

Looking southwest at dense trees on landward slope and toe.

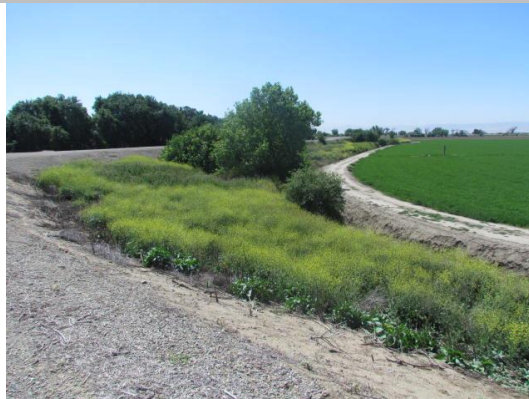
Photo 1 of 5 : SP_2015_RD0544_108_33_20150430_00084.jpg

LM Start	4.95	Rating **	M	Issue No.	33
LM End	5.26	Issue Type +	Ma	Location *	LS
Category	Earthen Levee			GPS Latitude/Longitude	
				Start	End
Item	Vegetation			37.818718 °	37.814662 °
				-121.319508 °	-121.320302 °
DWR ID	DWR_RD0544_01_s_2012_33				
Action/Comments					
Remove the wild growth other than native grasses from the levee slopes.					
Inspector Comments: Vegetation has been sprayed, but still blocking view of landward toe.

Looking southwest at dense vegetation at landward slope and toe. (Spring 2015)

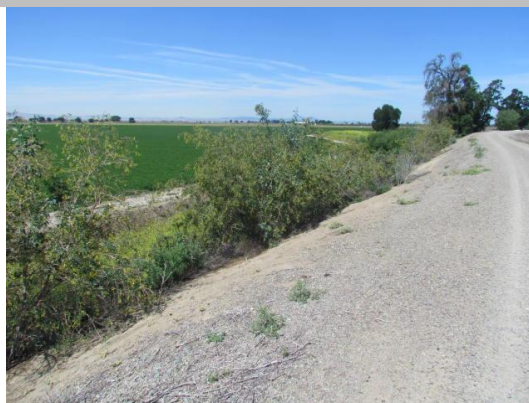
Photo 2 of 5 : SP_2015_RD0544_108_33_20150430_00085.jpg

Looking northwest at dense vegetation at landward toe. (Spring 2015)

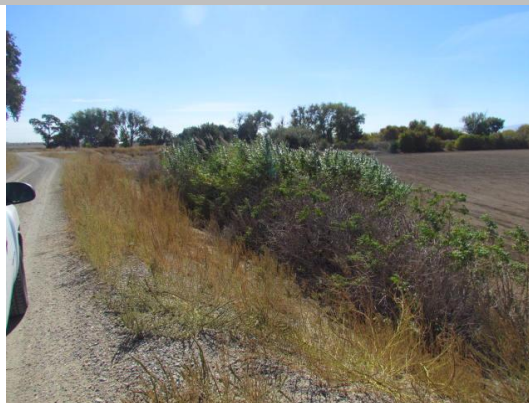
Photo 1 of 1 : SP_2015_RD0544_108_35_20150309_00032.jpg

LM Start	5.34	Rating **	U	Issue No.	35
LM End	5.34	Issue Type +	Ma	Location *	LS
Category	Earthen Levee			GPS Latitude/Longitude	
				Start	End
Item	Vegetation			37.813659 °	37.813659 °
				-121.319614 °	-121.319614 °
DWR ID	DWR_RD0544_01_s _ 2012_35				
Action/Comments					
Trees / Woody Vegetation					
Inspector Comments: Bamboo blocking landward toe.

Looking south at bamboo on landward slope and toe.

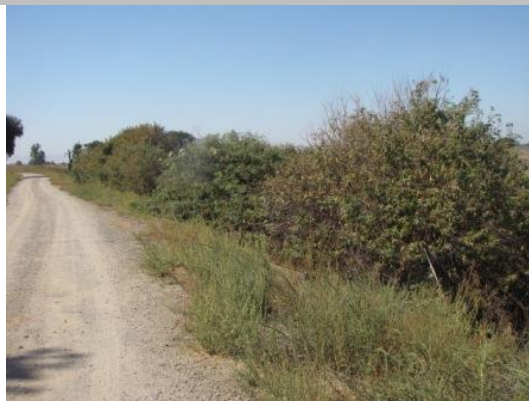
Photo 3 of 3 : SP_2015_RD0544_108_18_20150309_00023.jpg

LM Start	5.49	Rating **	U	Issue No.	18
LM End	5.55	Issue Type +	Ma	Location *	LS
Category	Earthen Levee			GPS Latitude/Longitude	
				Start	End
Item	Vegetation			37.812033 °	37.811687 °
				-121.319737 °	-121.320677 °
DWR ID	DWR_RD0544_01_s _ 2012_18				
Action/Comments					
Elderberries are blocking visibility and flood fight capability.

Looking southwest on elderberries on landside slope and toe.

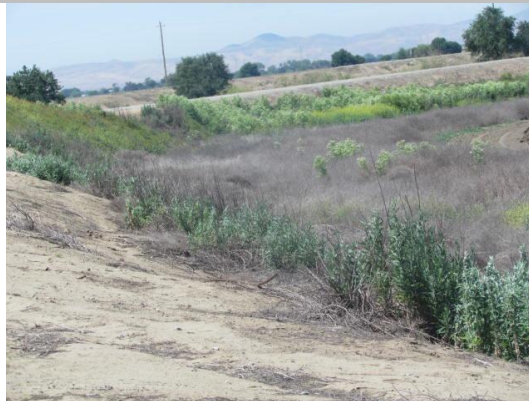
Photo 1 of 1 : SP_2015_RD0544_109_3_20150430_00053.jpg

LM Start	0.03	Rating **	U	Issue No.	3
LM End	0.37	Issue Type +	Ma	Location *	LS
Category	Earthen Levee			GPS Latitude/Longitude	
				Start	End
Item	Vegetation			37.808603 °	37.809442 °
				-121.328719 °	-121.334415 °
DWR ID	DWR_RD0544_02_s_2012_3				
Action/Comments					
Remove the wild growth other than native grasses from the levee slopes.

Looking south at dense vegetation at landward toe.

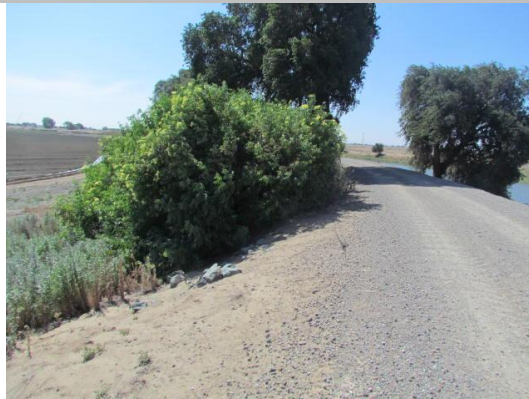
Photo 2 of 3 : SP_2015_RD0544_109_4_20150309_00002.jpg

Looking northwest at elderberry on landside slope. (Spring 2012)

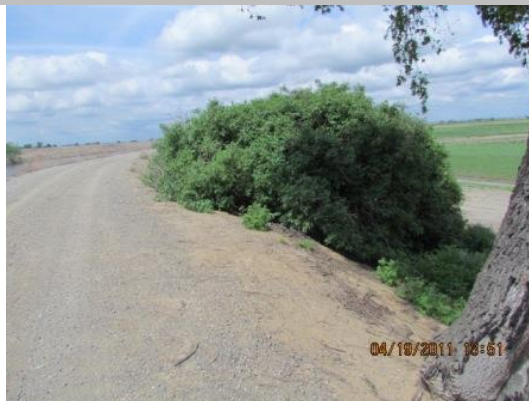
Photo 3 of 3 : SP_2015_RD0544_109_4_20150309_00003.jpg

Looking south at elderberries on landside slope.

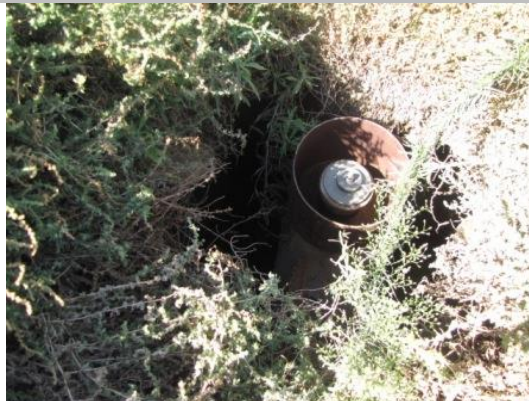
Photo 1 of 8 : SP_2015_RD0544_109_8_20150309_00006.jpg

Looking at top of siphon on waterside shoulder with 3' of caving around pipe.

LM Start	0.79	Rating **	U	Issue No.	8 (cont)	
LM End	0.79	Issue Type +	Ma	Location *	WS	
Category	Interior Drainage & Piping Systems			GPS Latitude/Longitude		
				Start	End	
Item	Erosion Areas			37.815160 °	37.815160 °	
				-121.333875 °	-121.333875 °	
DWR ID	DWR_RD0544_02_s_2012_8					
Action/Comments						
Inspector Comments: Caving under and around siphon on waterside shoulder. No material 3' below pipe. Caving around siphon is 20" to 24" deep approximately 72" in diameter. During 2012 spring inspection hole appears to be enlarging.

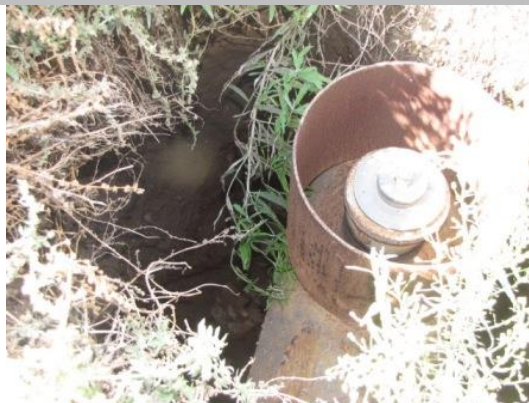
Photo 2 of 8 : SP_2015_RD0544_109_8_20150309_00007.jpg

Looking at caving around 10" siphon pipe on waterside shoulder.

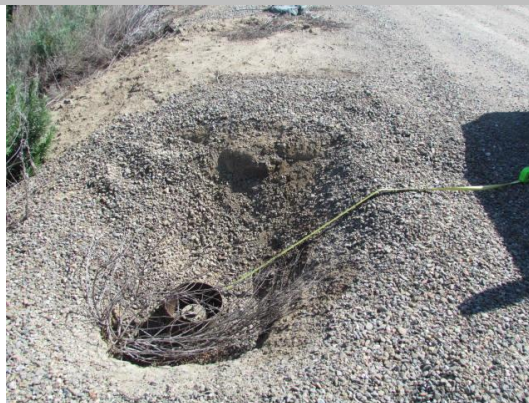
Photo 7 of 8 : SP_2015_RD0544_109_8_20150309_00012.jpg

Looking south at caving around siphon on waterside shoulder.(Spring 2012)

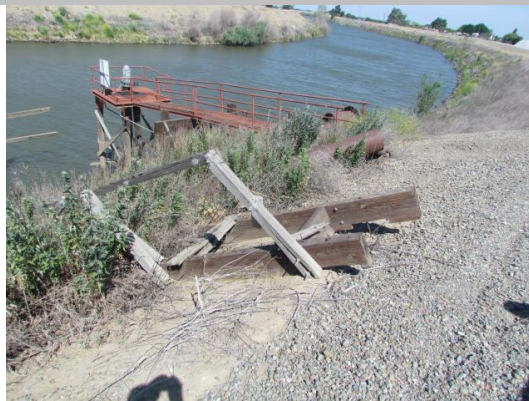
Photo 1 of 1 : SP_2015_RD0544_109_6_20150309_00005.jpg

LM Start	1.01	Rating **	M	Issue No.	6
LM End	1.01	Issue Type +	En	Location *	WS
Category	Earthen Levee			GPS Latitude/Longitude	
				Start	End
Item	Encroachments			37.818100 °	37.818100 °
				-121.332750 °	-121.332750 °
DWR ID	DWR_RD0544_02_s_2012_6				
Action/Comments					
Garbage

Looking southeast at garbage on waterside shoulder and slope.

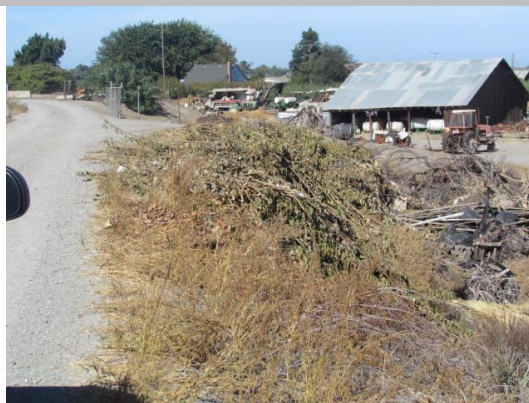
Photo 1 of 4 : SP_2015_RD0544_109_20_20150309_00024.jpg

LM Start	1.12	Rating **	U	Issue No.	20
LM End	1.12	Issue Type +	En	Location *	LS
Category	Earthen Levee			GPS Latitude/Longitude	
				Start	End
Item	Encroachments			37.819530 °	37.819530 °
				-121.333827 °	-121.333827 °
DWR ID	DWR_RD0544_02_s_2012_20				
Action/Comments					
Prunings Inspector Comments: Rubber tires and other items have been added to pruning pile.

Looking southwest at trash and pruning pile on landward shoulder and slope.

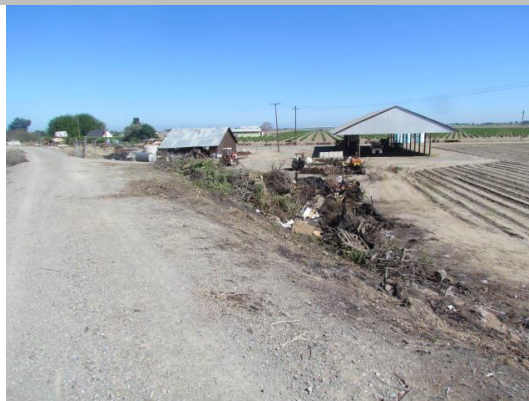
Photo 3 of 4 : SP_2015_RD0544_109_20_20150309_00026.jpg

LM Start	1.12	Rating **	U	Issue No.	20 (cont)	
LM End	1.12	Issue Type +	En	Location *	LS	
Category	Earthen Levee			GPS Latitude/Longitude		
				Start		End
Item	Encroachments			37.819530 °		37.819530 °
				-121.333827 °		-121.333827 °
DWR ID	DWR_RD0544_02_s_2012_20					
Action/Comments						
Prunings						
Inspector Comments: Rubber tires and other items have been added to pruning pile.

Looking southwest at pruning & garbage piles at landward toe. (Spring 2014)

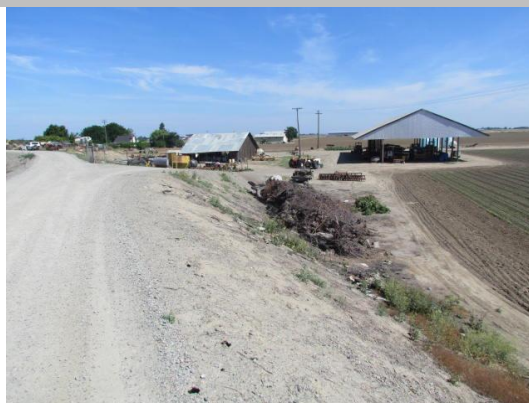
Photo 4 of 4 : SP_2015_RD0544_109_20_20150309_00027.jpg

Looking southwest at garbage and pruning pile at landside toe. (Spring 2012)

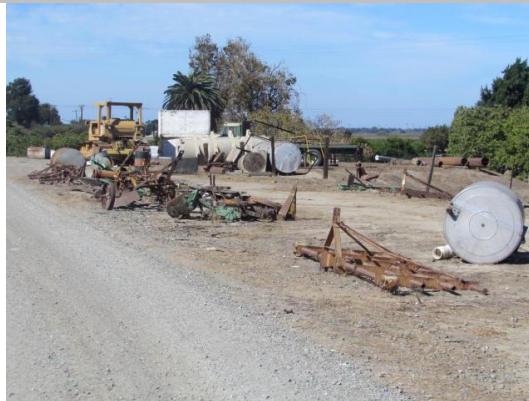
Photo 1 of 3 : SP_2015_RD0544_109_18_20150309_00021.jpg

LM Start	1.15	Rating **	M	Issue No.	18
LM End	1.22	Issue Type +	En	Location *	LS
Category	Earthen Levee			GPS Latitude/Longitude	
				Start	End
Item	Encroachments			37.819830 °	37.820235 °
				-121.334233 °	-121.335268 °
DWR ID	DWR_RD0544_02_s_2012_18				
Action/Comments					
Abandoned vehicles Inspector Comments: Vehicles and farm equipment stored on landside for several years. Area is defined a oversized levee. Landowner is in the process of moving items from landward shoulder.

Looking southwest at equipment stored on landward shoulder.

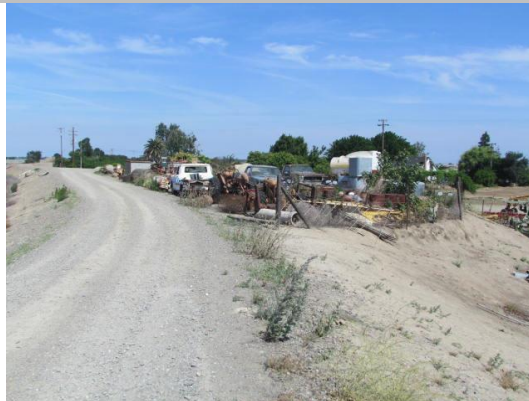
Photo 2 of 3 : SP_2015_RD0544_109_18_20150309_00022.jpg

Looking southwest at vehicles and farm equipment stored on landside landing.

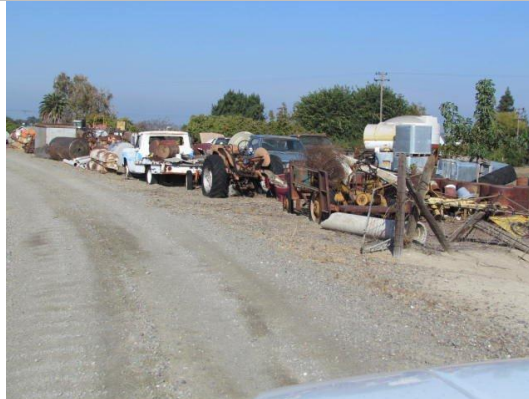
Photo 3 of 3 : SP_2015_RD0544_109_18_20150309_00023.jpg

Looking southwest at farm equipment, vehicles, and other items stored on landside landing.

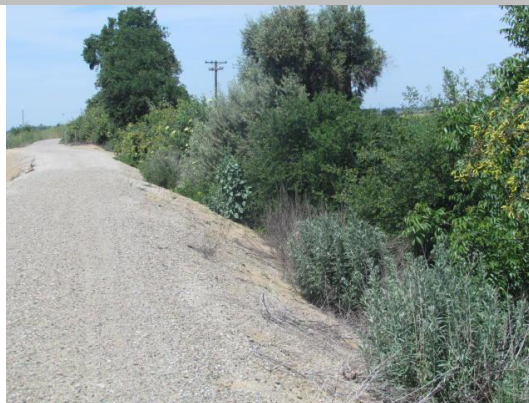
Photo 1 of 2 : SP_2015_RD0544_109_49_20150430_00056.jpg

LM Start	1.30	Rating **	U	Issue No.	49
LM End	1.40	Issue Type +	Ma	Location *	WS
Category	Earthen Levee			GPS Latitude/Longitude	
				Start	End
Item	Vegetation			37.820767 °	37.821582 °
				-121.336611 °	-121.338102 °
DWR ID	DWR_RD0544_02_f_2014_49				
Action/Comments					
Remove the wild growth other than native grasses from the levee slopes.					
Inspector Comments: Tobacco plants on waterward slope.

Looking southwest at dense vegetation on landward slope and toe.

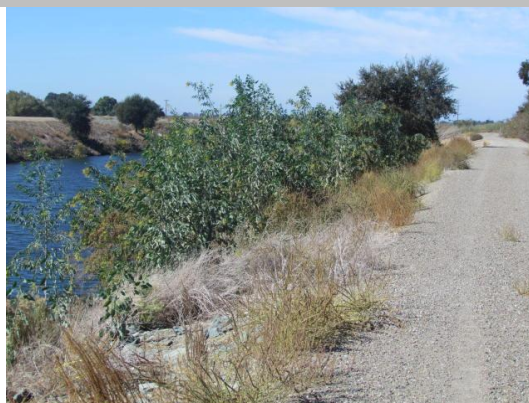
Photo 2 of 2 : SP_2015_RD0544_109_49_20150309_00040.jpg

Looking south at several tobacco plants on waterward slope.

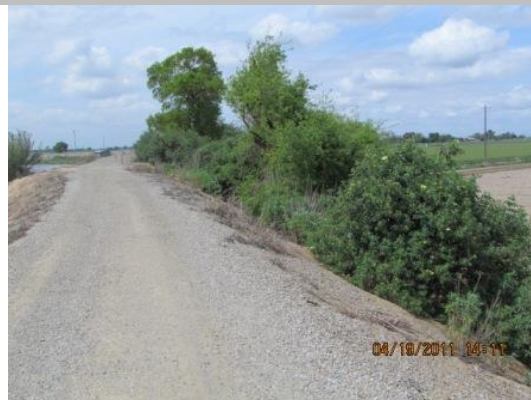
Photo 1 of 2 : SP_2015_RD0544_109_10_20150309_00015.jpg

LM Start	1.38	Rating **	U	Issue No.	10
LM End	1.38	Issue Type +	Ma	Location *	LS
Category	Earthen Levee			GPS Latitude/Longitude	
				Start	End
Item	Vegetation			37.821423 °	37.821423 °
				-121.337878 °	-121.337878 °
DWR ID	DWR_RD0544_02_s _ 2012_10				
Action/Comments					
Elderberries are blocking visibility and flood fight capability.

Looking southwest at elderberries on landside slope.

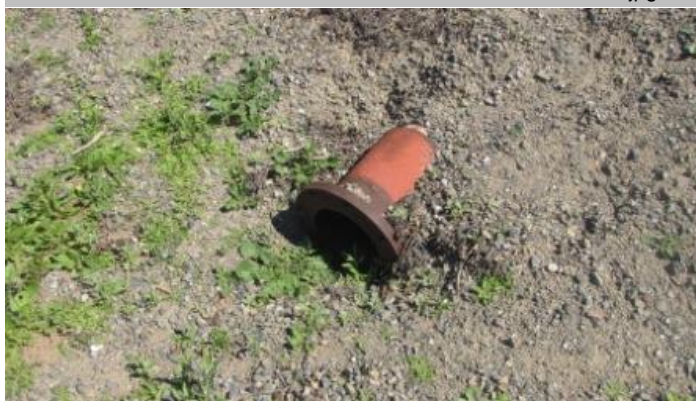
Photo 2 of 3 : SP_2015_RD0544_109_21_20150309_00029.jpg

Looking west at east end of pipe on waterside slope.

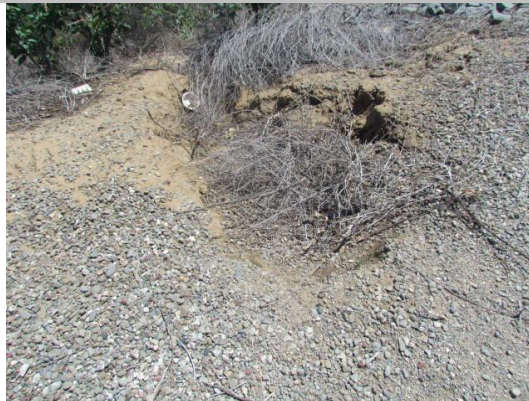
Photo 1 of 2 : SP_2015_RD0544_109_38_20150430_00057.jpg

LM Start	1.86	Rating **	U	Issue No.	38
LM End	1.86	Issue Type +	Ma	Location *	WS
Category	Earthen Levee			GPS Latitude/Longitude	
				Start	End
Item	Erosion / Bank Caving			37.817983 °	37.817983 °
				-121.341682 °	-121.341682 °
DWR ID	DWR_RD0544_02_s _ 2015_38				
Action/Comments					
Note and monitor erosion site.					
Inspector Comments: Erosion/Caving on waterward shoulder and slope 18" x 6" x 15'.

Looking southeast at erosion/caving on waterward slope.

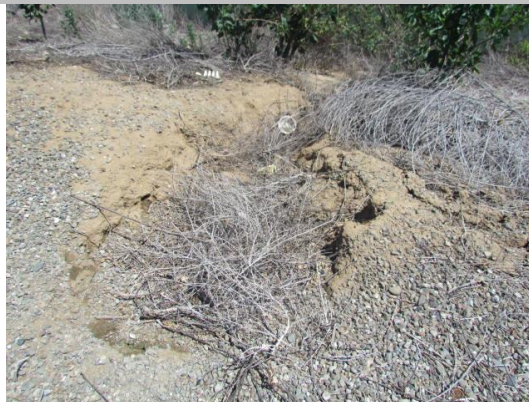
Photo 2 of 2 : SP_2015_RD0544_109_38_20150430_00058.jpg

Looking east at erosion/caving on waterward slope.

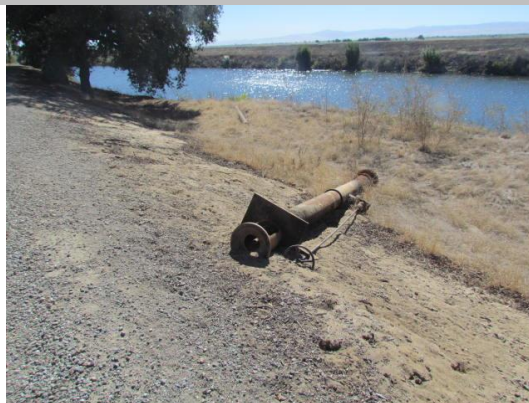
Photo 1 of 1 : SP_2015_RD0544_109_50_20150309_00041.jpg

LM Start	2.21	Rating **	M	Issue No.	50
LM End	2.21	Issue Type +	Ma	Location *	WS
Category	Earthen Levee			GPS Latitude/Longitude	
				Start	End
Item	Encroachments			37.820646 °	37.820646 °
				-121.346014 °	-121.346014 °
DWR ID	DWR_RD0544_02_f _ 2014_50				
Action/Comments					
Garbage					
Inspector Comments: Discarded intake pipe on waterward slope.

Looking northwest at pipe on waterward slope.

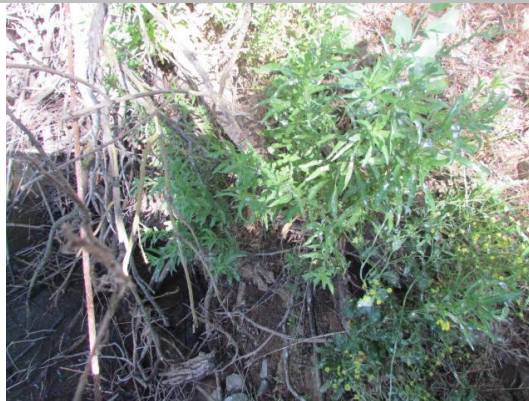
Photo 1 of 3 : SP_2015_RD0544_109_24_20150309_00034.jpg

LM Start	2.31	Rating **	U	Issue No.	24
LM End	2.31	Issue Type +	Ma	Location *	WS
Category	Rivers, Channels & Designated Floodways			GPS Latitude/Longitude	
				Start	End
Item	Erosion / Bank Caving			37.821763 °	37.821763 °
				-121.347275 °	-121.347275 °
DWR ID	DWR_RD0544_02_s_2012_24				
Action/Comments					
Inspector Comments: Large erosion and beaver activity at waterside toe of levee.

Looking south at beaver hole at waterside toe.

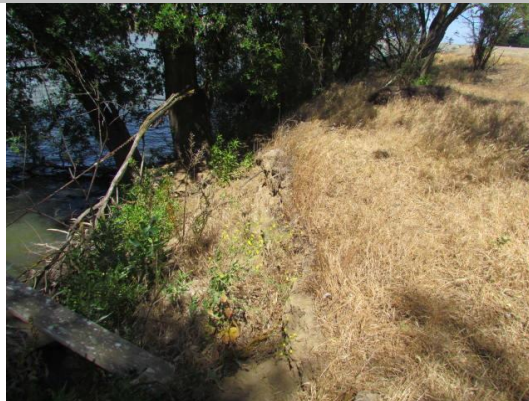
Photo 2 of 3 : SP_2015_RD0544_109_24_20150309_00035.jpg

Looking south at river erosion at waterside toe near pumping station.

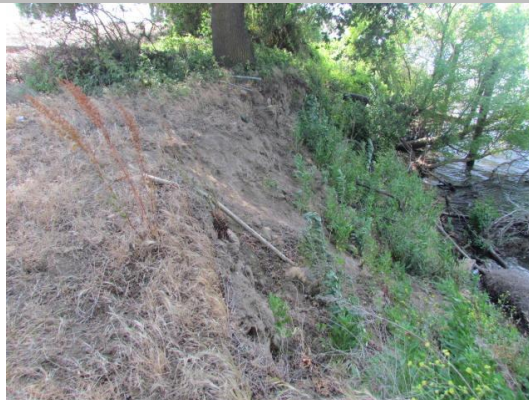
Photo 3 of 3 : SP_2015_RD0544_109_24_20150309_00036.jpg

Looking north at erosion on waterside slope.

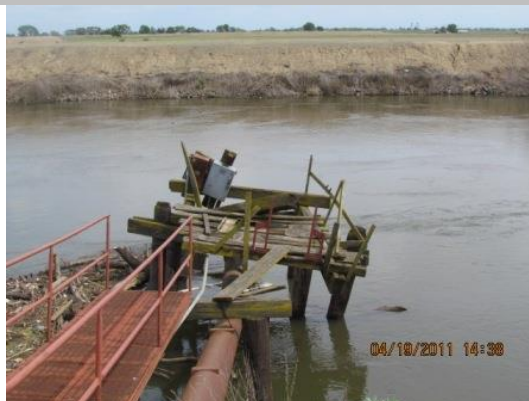
Photo 1 of 1 : SP_2015_RD0544_109_17_20150309_00020.jpg

Looking east at dilapidated pump platform.

LM Start	2.61	Rating **	U	Issue No.	17
LM End	2.61	Issue Type +	En	Location *	WS
Category	Rivers, Channels & Designated Floodways			GPS Latitude/Longitude	
				Start	End
Item	Encroachments			37.818872 °	37.818872 °
				-121.350392 °	-121.350392 °
DWR ID	DWR_RD0544_02_s_2012_17				
Action/Comments					
Inspector Comments: Remove dilapidated pump platform from river.

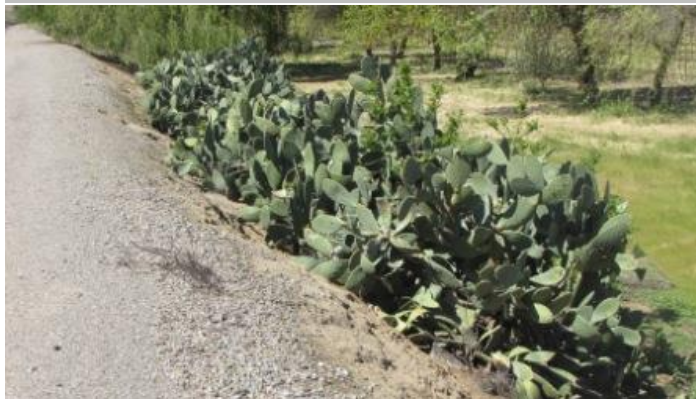
Photo 2 of 2 : SP_2015_RD0544_109_36_20150309_00038.jpg

Looking southwest at overgrown cactus on landside slope.

LM Start	3.48	Rating **	M	Issue No.	36 (cont)
LM End	3.51	Issue Type +	Ma	Location *	LS
Category	Earthen Levee			GPS Latitude/Longitude	
				Start	End
Item	Vegetation			37.819576 °	37.819530 °
				-121.364056 °	-121.364653 °
DWR ID	DWR_RD0544_02_s_2012_36				
Action/Comments					
Remove the wild growth other than native grasses from the levee slopes.					
Inspector Comments: Cactus on landside slope.
